**MOBILE/MANUFACTURED HOME
DAMAGE REPORT**

TORNADO IN ESCAMBIA COUNTY

February 18, 2008

SUBJECT: Tornado Damage to Mobile/Manufactured Homes in Escambia County

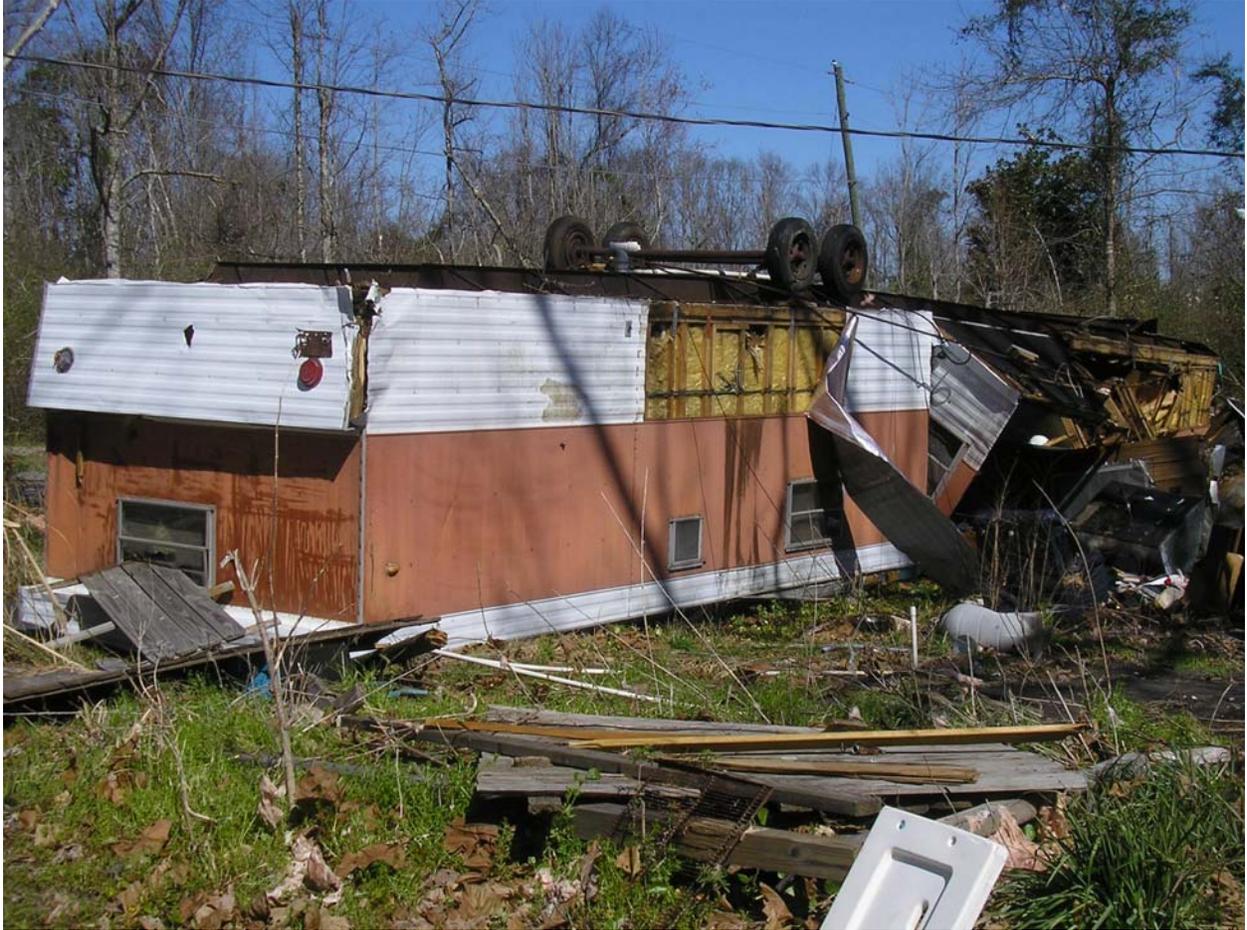
Date of Investigation	February 19, 2008	County	Escambia	Consultant	David W. Cowfer
Homeowner and Home's Location		Installer			
Billy Sims 6398 Brickyard Road Molino, Florida		N/A			
Anchor Length	30" with two – 3" helix	Mobile Home Description			
Spacing	Three anchors each side	MFG:	N/A	Single	X
Stabilizer Plates	N/A	L X W	10' X 50'	Double	
LSD System Used	N/A	HUD #	N/A	Triple	
Lateral System Used	N/A	VIN #	N/A	New	
Probe Test	N/A	Decal #	N/A	Used	X
Pier Spacing	All removed by owner	Date Installed	1970s	W.Z.	
Pier Pad Size	16" X 16" concrete	Date of MFG. or Year Model		Pre-HUD	
Condition of Anchors:		Rusted			
Condition of Stabilizer Plates:		N/A			
Condition of Piers		N/A			
Condition of Pier Pads		N/A			
Condition of LSD System		N/A			
Condition of Lateral Systems		N/A			
Type of Storm		Supporting Items		Photographs	
Thunderstorm		Newspapers		Home	X
Tornado	X	DCA's EOC	X	On Foundation	
Hurricane		Other:		Off Foundation	X

Windshear				Piers	
Flood					
Description of the Home's Condition					
Destroyed. The home rolled over on its roof. Owner was inside the home when it rolled. Just bruises and scratches. No one sustained major injuries. The galvanized straps were rusted and broke free from the anchors. The owner pulled the anchors out of the ground by hand after the home rolled.					
Description of the Mobile Home Park or Surrounding Area:					
Subdivision in a rural community. A mixture of site built and manufactured homes on approximately half acre lots.

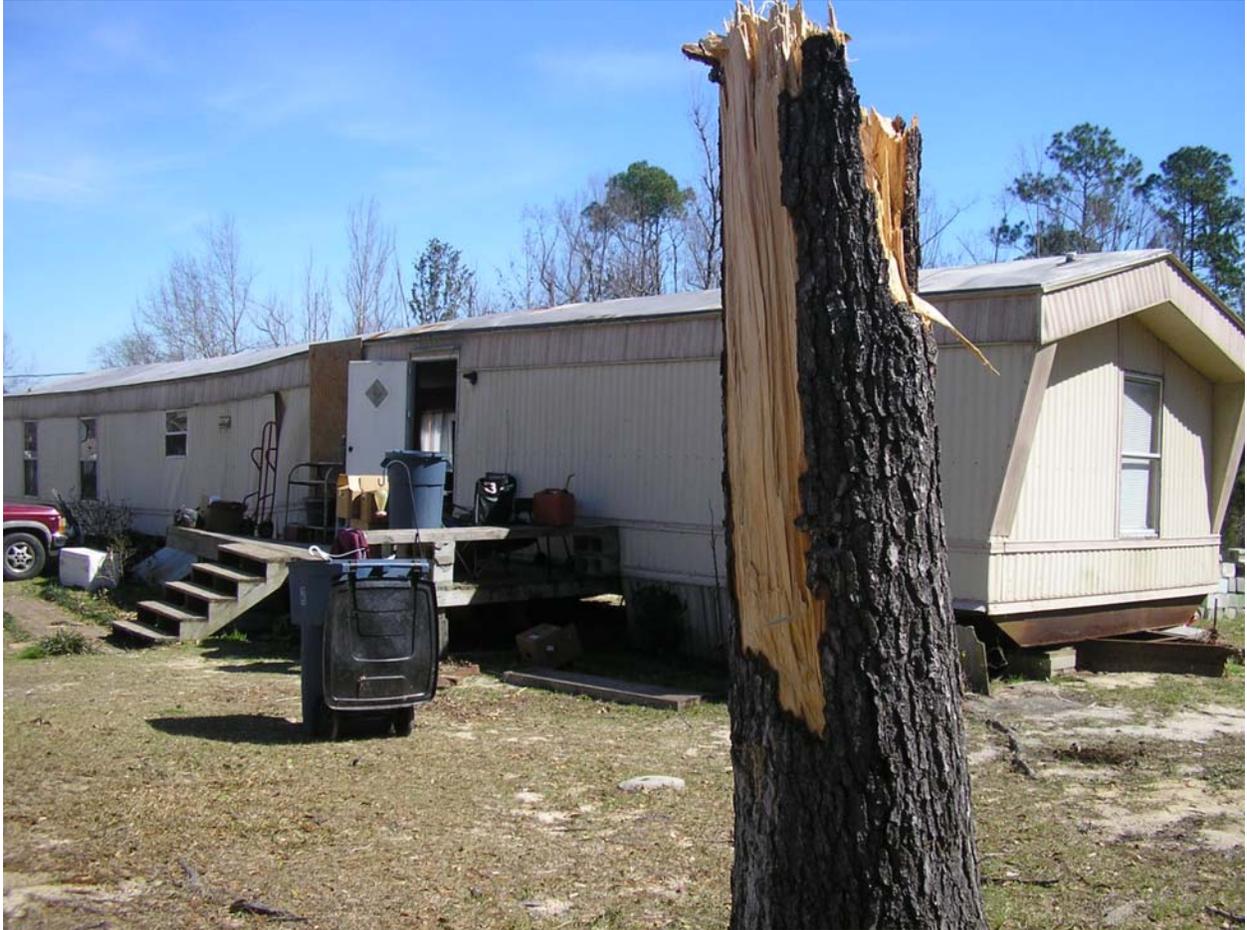
Date of Investigation	February 19, 2008	County	Escambia	Consultant	David W. Cowfer		
Homeowner and Home's Location			Installer				
Elsie Hiatt 125A Molino Road Molino, Florida			N/A				
Anchor Length	4' painted steel	Mobile Home Description					
Spacing	Approximately 10 ft. o/c	MFG:	N/A	Single	X		
Stabilizer Plates	N/A	L X W	14' X 76'	Double			
LSD System Used	N/A	HUD #	NTA256569	Triple			
Lateral System Used	N/A	VIN #	N/A	New			
Probe Test	N/A	Decal #	N/A	Used	X		
Pier Spacing	8' O/C	Date Installed	Early 1990s	W.Z.	II		
Pier Pad Size	16" X 16" concrete	Date of MFG. or Year Model		Early 1990s			
Condition of Anchors:		Surface rust. Appears to have not moved at all.					
Galvanized straps were rusted and no longer attached to the anchors. Four over the roof straps existed; one on one end held.							
Condition of Stabilizer Plates:		N/A					
Condition of Piers		Still standing. It appears the home was lifted off the piers and shifted sideways approximately eight feet on one end leaving all the piers standing.

Condition of Pier Pads		Buried the depth of the pad. 16" X 16" concrete.					
Condition of LSD System		N/A					
Condition of Lateral Systems		N/A					
Type of Storm		Supporting Items		Photographs			
Thunderstorm		Newspapers		Home	X	Anchors	X
Tornado	X	DCA's EOC	X	On Foundation		Stabilizer Plates	
Hurricane		Other:		Off Foundation	X	LSDs and Laterals	
Windshear				Piers	OK	Other	
Flood							
Description of the Home's Condition							
Destroyed. The home appears to have lifted off the piers and shifted approximately eight feet on one end and rested on the porch deck. (Porch may have assisted in stopping the home from rolling over.)							
The home broke in half.							
Description of the Mobile Home Park or Surrounding Area:							
Rural community. Subdivision with a mixture of site built and manufactured homes on approximately half acre lots.
